## Heavy Ion SEE Test Report for the Micron 4Gbit NAND Flash Memory for MMS

Test Date: 3-4 Nov 2008

Report Date: 27 Jan 2009

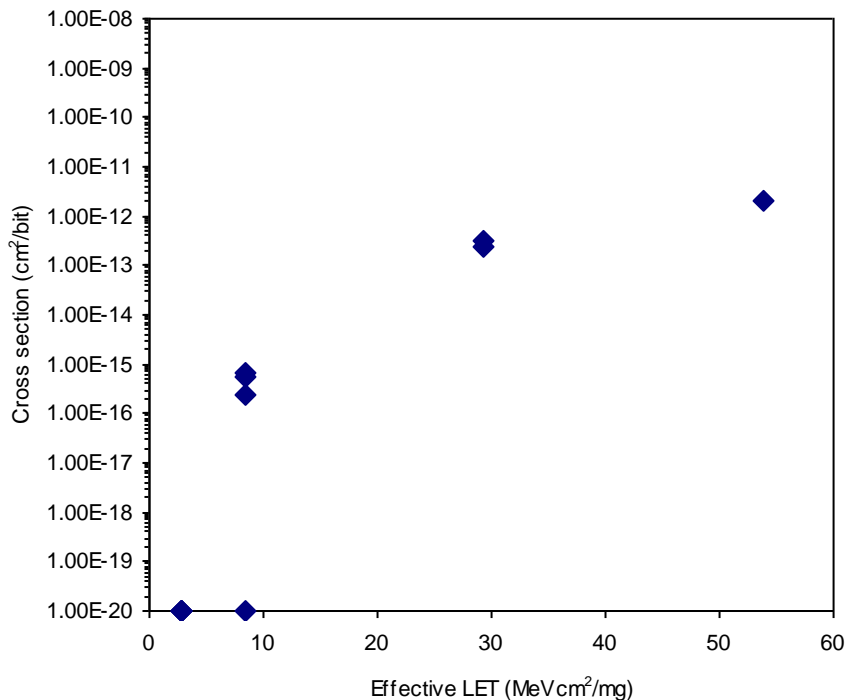
During testing, the DUTs were irradiated with the ions indicated in Table I. The DUT was oriented normal to the incident beam, except as noted. The errors observed in static SEU testing are shown in Fig. 4a, with no bias applied. In Fig. 4a, the vertical axis is in units of  $\text{cm}^2/\text{bit}$ , as is commonly done for SEU testing. The same data is shown in Fig. 4b, with the vertical axis in units of  $\text{cm}^2/\text{device}$ , so that SEFI results can be plotted on the same scale.

Even for the static unbiased case, bit errors and two SEFIs with one destructive failure were observed. The most common SEFI mode, generally, was a Block error. One of the static unbiased SEFIs was a block error, where an entire block was lost, presumably from the effects of a single ion. It is likely that Page/Block errors arise due to upsets in configuration registers in the memory array. The other SEFI was different, affecting some bits in every block in the memory. The destructive failure was the loss of the erase function, probably due to damage to the charge pump, which was surprising only because the charge pump was unbiased. The exposures that produced the SEFIs and the destructive failure were at 45 degrees, because we were trying to determine the worst case angle and the angular dependence of the effects. (In Fig 4b, the angular shots are plotted at  $\text{LET}=11.4$ , nominal  $\text{LET}/\cos \theta$ .) However, we did not have

Fig. 4. Results in static test mode: (a) SEU results; (b) SEU results and SEFI results on the same scale.

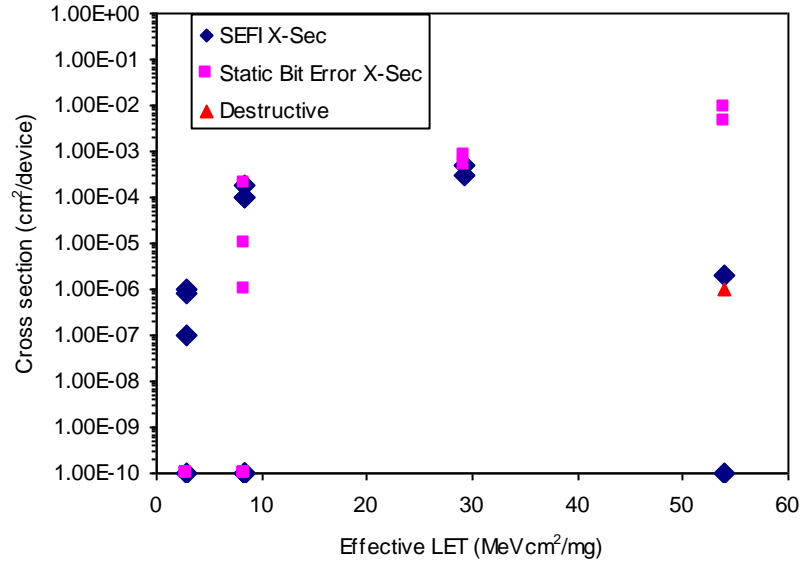
Fig. 5. Results for static mode, with bias applied.

The results for static mode with bias applied are shown in Fig. 5. The SEFI cross section is equal or greater than the bit error cross section at all but the highest LET. These SEFIs are mostly block errors, where every bit in a 128Kx8 block is read as a zero (compared to a checkerboard that was actually stored). After the beam is turned off, multiple reads produce the same result, until power is cycled. After cycling power, the DUT can be read normally—the stored pattern is still stored, except for perhaps the occasional single bit error. Thus, there is a relatively simple way to recover from SEFIs in these NAND flash chips, because the nonvolatile technology is designed to retain information with the power turned off. The recovery method described here also works in all the other test modes, although the SEFI rate is initially higher in some of the dynamic test modes. We note that the single bit error cross sections in Fig. 5 are very similar to those in Fig. 4, although the SEFI rate is higher with bias applied. We also note that there are no results in Fig. 5 for angles other than normal incidence, which is not the case in Fig. 4. Otherwise, the difference in SEFI rates would be even greater. The destructive failure was a latchup, even though the test was not done at elevated temperature or voltage. After cycling power, the erase function did not work.

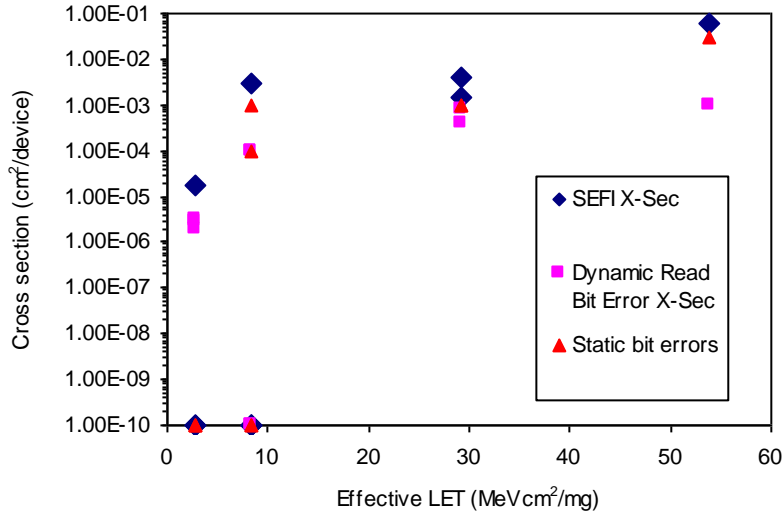
Fig. 6. Results for Dynamic Read mode.

For the Dynamic Read condition, the parts showed exhibited transient read errors in addition to the bit and Block errors, and other SEFIs, which are plotted in Fig. 6. In this mode, the DUT reads continuously with the beam on. The SEFI cross sections in Fig. 6 are roughly two orders of magnitude larger than the static mode results in Fig. 5. This result is not surprising—the more functions the control logic performs with the beam on, the more likely it is to have major errors. The static bit errors are those remaining after power is cycled, as before, and also as they will be for the remaining test modes. Transient bit errors, again, will be those that reset when power is cycled, if not before. Some transient errors are bits read erroneously, due to noise in the read circuit, which will be read correctly on the next pass through the memory. Others will be repeated on subsequent reads, but they are corrected by cycling power.

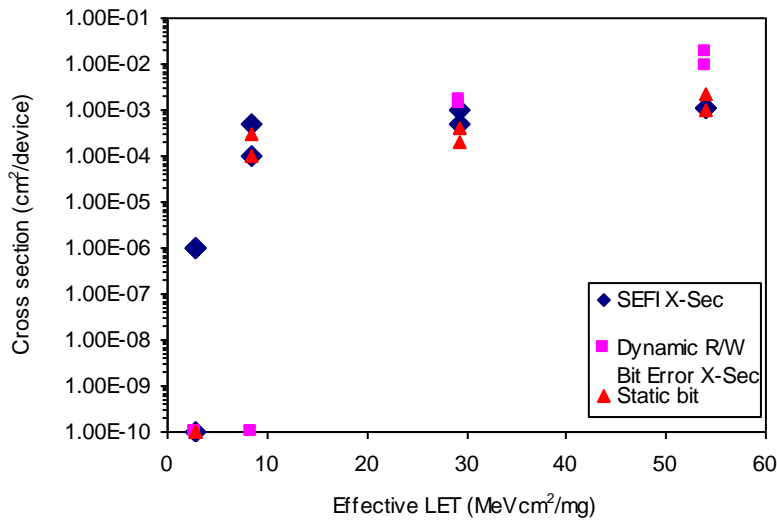
Results of the dynamic R/W tests are shown in Fig. 7. Generally these results are unremarkable, because the usual zero-to-one errors are rewritten as they occur. For this reason, there are fewer errors indicated than in Fig. 6, although the difference is not large. The main reason for including this test was the expectation that the high voltage write operation would contribute to more errors in the control circuits, but this appears not to have happened, at least not on a large scale. Probably, this is because the write operation is performed only when a zero-to-one error is detected. For this circuit, there are relatively few such errors, so the write circuit duty cycle is a very small number. Where a static cross section is given, it is based on the number of errors detected after the exposure and resetting of the DUT, as before. The transient cross section is based on errors detected during the exposure. But some of the transient errors are probably really static bit errors that were rewritten during the test.

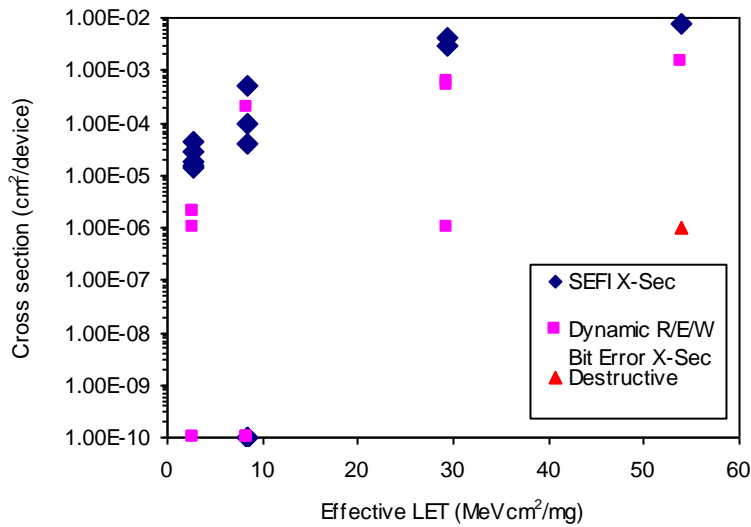
Fig. 8. Dynamic Read/Erase/Write results.

Results for the dynamic R/E/W tests are shown in Fig. 8, to the extent that they can be determined. For this condition, there were many more SEFIs than in the R/W (without erase) mode, which is probably due to the fact that every block is erased and rewritten on every cycle, so that the duty cycle for high voltage operations is much higher. As a practical matter, there are many page and block errors, which usually appear to be independent, on almost every shot with LET at or above 8.4 (Ar). With many large chunks of the memory completely knocked out, it becomes difficult to determine static or transient errors affecting only single bits. The one destructive failure was a latchup, with current jumping to about 80 mA almost as soon as the beam was turned on and staying there until power was cycled, about two minutes later. Afterwards, the DUT could be read normally, but the erase function had been destroyed. This exposure was performed at  $T=70^{\circ}\text{C}$ , and  $V_{dd}=3.6\text{ V}$ .
